Slope Stability Hazard Assessment and Mitigation Methodology Along Eastern Desert Aswan-Cairo Highway, Egypt

Ahmed M. Youssef and Norbert H. Maerz

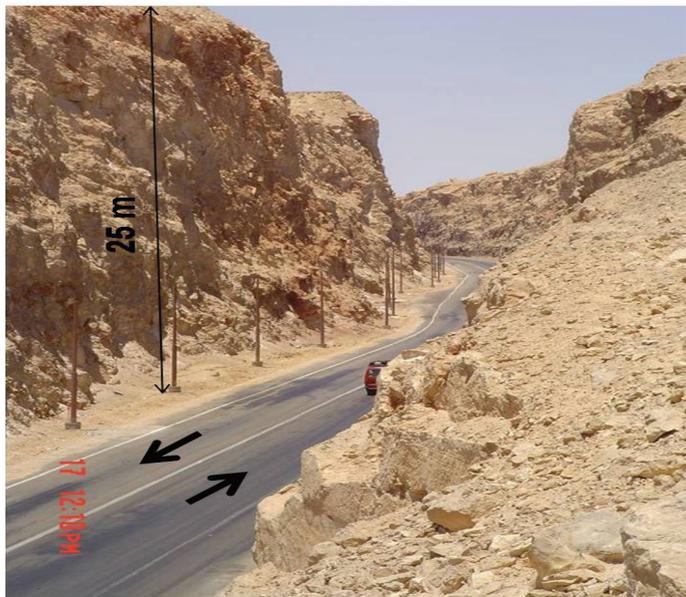
Fig. 2. An overview of the desert highway along the cut section showing the horizontal and vertical curvature of the road. The road has small shoulder, with no ditch, and one traffic lane in each direction.

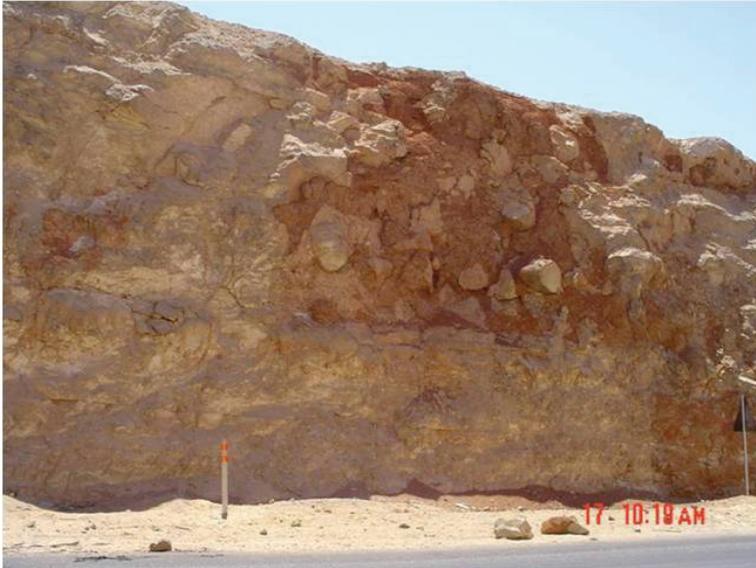
The limestone of the rock cut is characterized by the presence of filled sinkholes (Fig. 4). These have been found to be of importance to slope stability. The sinkholes are filled with material of a variety of block sizes ranging from 20 cm to 1 m and are weakly cemented with reddish sandy muddy materials that are easily eroded. Karst features are nearly always found to originate from solution cavities along discontinuities. This leaves cavities supported by remnant points of contact across opened discontinuities. A diminished contact area reduces the shear strength, and points of contact may break due to overstressing. The

presence of these filled sinkholes during excavation, have an adverse effect on the slope stability. During blasting the explosion gases will force their way out of the rock mass via the karstic discontinuities rather than by breaking intact rock or by following discontinuities to the next borehole.

Fig. 4. Sinkhole filled with boulders of different sizes and cemented with reddish weak materials (clayey sand with a reddish matrix).
